Flanking paths associated with exposed roof decks in condominiums

Jeffrey P. Kwoikoski^{a)}
D. L. Adams Associates, Inc.
1701 Boulder Street
Denver, CO 80211

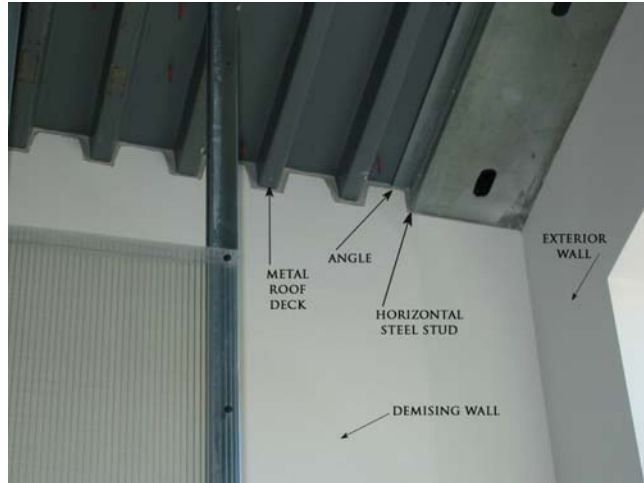
Fig. 2 - Photograph of horizontal stud.

I was able to use a ladder to observe the top of the wall near the metal roof deck. Sound appeared to be coming from a horizontal 305 mm (12") steel stud that penetrated the wall against the underside of the roof deck at the exterior wall. Refer to **Figure 2** for a photograph of this condition.

The contractor indicated that the horizontal stud served as bracing during construction. There was no gypsum board behind the stud (between the stud and the roof deck). The stud was no longer needed structurally, however, the stud was an integral part of the appearance of the units now and could not be removed to seal the hole in the gypsum board.

The sound was traveling into the stud on one side of the wall, laterally through the stud and through the hole in the wall, and then out the exposed stud on the other side of the wall. We decided that the most reliable solution was to wrap the horizontal stud within a unit, from the demising wall on one side to the demising wall on the other side.

First, fiberglass batt insulation was stuffed into the stud (through holes in the stud) as much as possible within about one meter of each side of the wall to provide sound absorption inside the stud cavity. Then the stud was covered with cellulose fiberboard to add mass to the sound barrier on each side of the wall. The fiberboard was fastened directly to the underside of the stud. Finally, the fiberboard was covered with sheet metal for aesthetic purposes. Refer to **Figure 4** for the detail. This detail was implemented in two side-by-side condominiums.

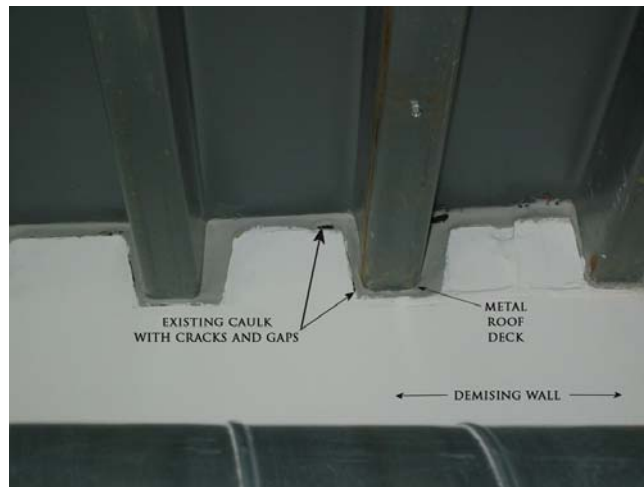
Fig. 3 - Photograph of joint between wall and roof deck.

The joint between the top of the wall and the metal roof deck was caulked, but the caulk had cracked in many places and no longer provided an airtight seal. Sound was likely leaking through this joint. Refer to **Figure 3** for a photograph. There was no caulk between the bottom of the wall and the concrete floor slab.

The joint at the top of the wall was recaulked on each side. The joint at the floor was caulked on both sides.

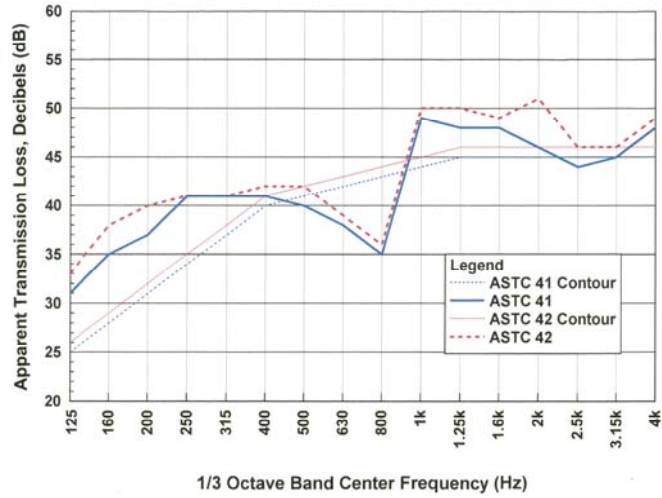
Fig. 5 - ASTC test results.

deck. The ASTC was 41. Refer to the “ASTC 41” curve in **Figure 5** for the test results, and refer to **Figure 6** for the floor plan of the two units. The ASTC rating was limited by the large dip in sound Transmission Loss at 630 Hz and 800 Hz.

The ASTC 41 rating was well below the design rating of STC 58. The ASTC 58 rating requires properly designed and installed resilient channels. However, the resilient channels would have to be completely ineffective to account for the ASTC 41 rating, and the dip in Transmission Loss at 800 Hz was not typical of resilient channel problems. The obvious airborne flanking paths and leaks noted during our first visit had already been remedied before the ASTC test. Based on the test results, it appeared that significant flanking paths still existed.

A second ASTC test was performed. The ASTC test result was 42. The ASTC increased by one point. Sound transmission loss increased somewhat below 250 Hz and above 800 Hz, but the ASTC was still limited by the dip at 630 Hz and 800 Hz. Please refer to the “ASTC 42” curve in Figure 5. Subjectively, the strongest sound appeared to be coming from the roof deck. Sound was audible in the exterior wall to a lesser degree.

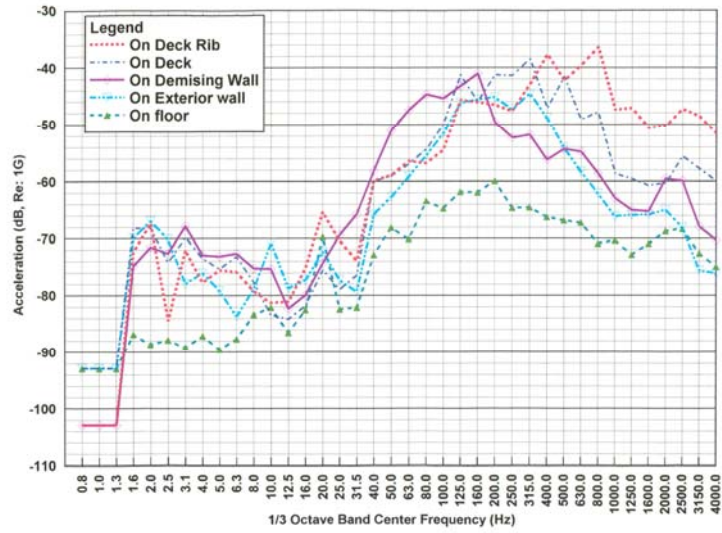
Fig. 7 - Vibration measurements.

During the ASTC testing, vibration was measured on several surfaces on the receiving side of the test wall while pink noise was generated at high levels on the source side. A Larson Davis 2900 real time analyzer was used together with a Brüel & Kjær Type 4370 54 gram accelerometer to measure vibration levels in one-third octave bands and narrow bands. The vibration levels were averaged over 30-second durations. Acceleration was measured on the demising wall, on the exposed roof deck at a location 914 mm (36") from the wall, on the concrete floor, and on the exterior wall. The measured acceleration levels are plotted in **Figure 7**.

The “deck” measurement was taken on the upper flat portion of the deck (the highest point). The “rib” measurement was on the rib of the deck (the lowest point). Note that the “rib” acceleration levels peak at 800 Hz, while the “deck” measurements peak at 400 Hz. The rib vibration correlated much closer to the dip in Apparent Transmission Loss evident in the ASTC tests. The acceleration levels on the walls and floor at 630 Hz and 800 Hz were more than 15 decibels below the levels on the roof deck ribs.

The vibration peak at 800 Hz on the rib of the roof deck correlated to the dip in apparent transmission loss in the ASTC test results. Using the acceleration levels on the deck, we estimated the sound pressure level in the room that should be expected from the acceleration levels on the roof deck.² We estimated a sound pressure level of approximately 55 decibels at 630 Hz and 800 Hz. The ASTC receiving room measurements made simultaneously with the vibration measurements were 55 and 55 decibels at 630 Hz and 800 Hz, respectively. We now

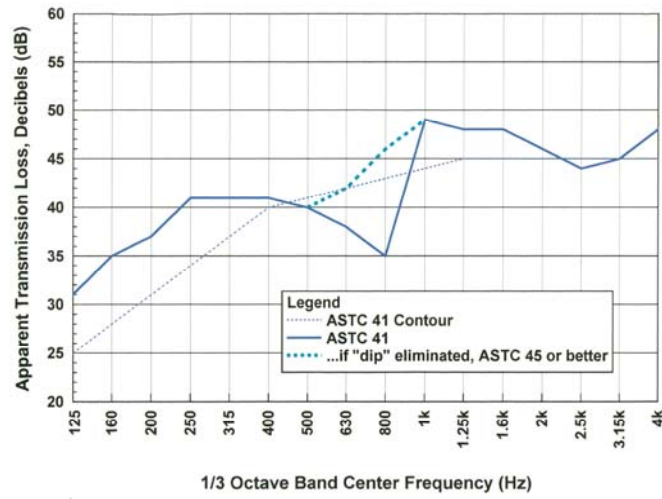
Fig. 8 - ASTC estimate if "dip" eliminated.

From the first ASTC test plot, it was clear that if the dip at 630 Hz and 800 Hz could be eliminated, the wall should yield an ASTC 45 or better. Refer to the illustration in **Figure 8**. The challenge was how to achieve this.

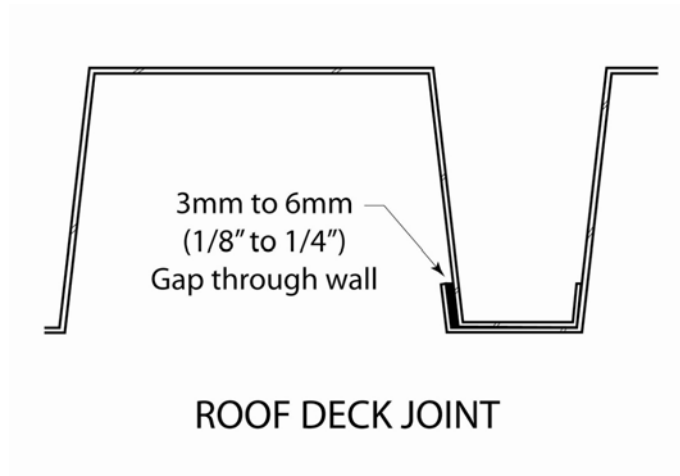
Fig. 9 - Detail of joint in metal roof deck.

Further subjective investigation was done on the receiving side of these walls while pink noise was generated at high levels on the source side. Airborne sound flanking was still evident at the joints of the metal deck. The concrete had not filled the joints as expected.

we felt that it should give some improvement, and only three to five decibels of improvement at 800 Hz was needed to raise the ASTC to 45 or better. We also expected that pouring the concrete would at least partially seal the joint between metal deck sections. Refer to **Figure 9** for an illustration of where the leaks occurred at the metal roof deck joints. If any sound was traveling over the wall through the hollow “channels” created between the deck flutes and the rigid insulation, the concrete strip would close this path as well. The concrete strip option was deemed the best option available and the contractor decided to try the approach over the test demising wall. See **Figure 10** for the detail that was used.

Wherever they were accessible, these joints were caulked on each side of the wall, from the wall out for a distance of approximately one meter out from the wall. The joints occurred every 610 mm (24"). The investigation also revealed several concealed conditions where airborne sound leaks were still present.

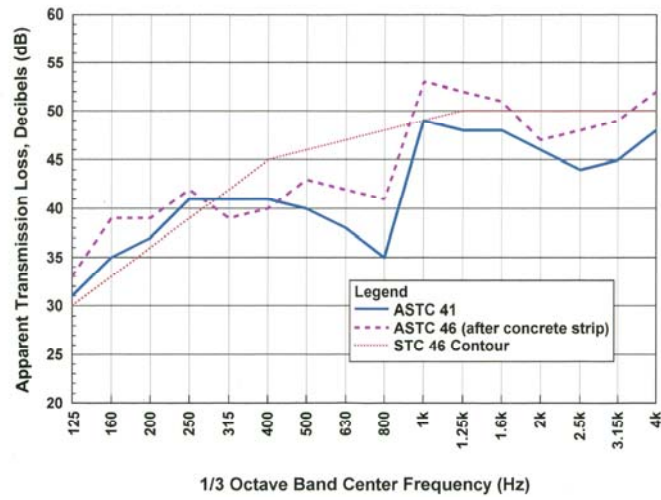
Fig. 11 -ASTC test results, before and after concrete strip.

In September 2008, the roof was cut and a concrete strip was poured over one wall. Approximately one week later, the ASTC of the wall was measured to be ASTC 46 - an improvement of 4 points from ASTC 42. The plotted data is shown in **Figure 11**. The Apparent Transmission Loss was improved by 3 and 5 decibels at 630 Hz and 800 Hz, respectively.

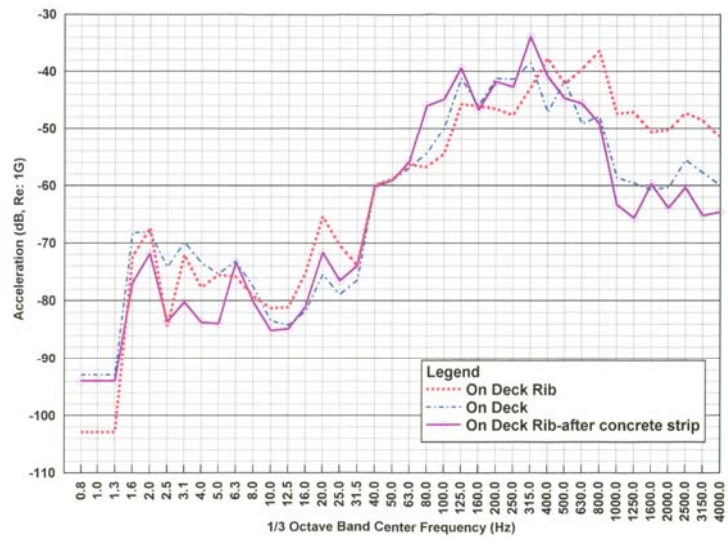
Fig. 12 - Vibration measurements after concrete strip installed.

Vibration levels were remeasured in the same locations. The results are shown in **Figure 12**. The acceleration level at 630 Hz and 800 Hz was reduced by 6 and 13 decibels, respectively.
