## **Case study: Mitigation of excessive vibration induced by commercial washers on elevated post-tensioned concrete slab**

Andrew J. Kowalyshyn<sup>a</sup>  
Jeffrey P. Kwoikoski<sup>b</sup>  
D. L. Adams Associates, Inc.  
1701 Boulder Street  
Denver, CO 80211  
USA

### **ABSTRACT**

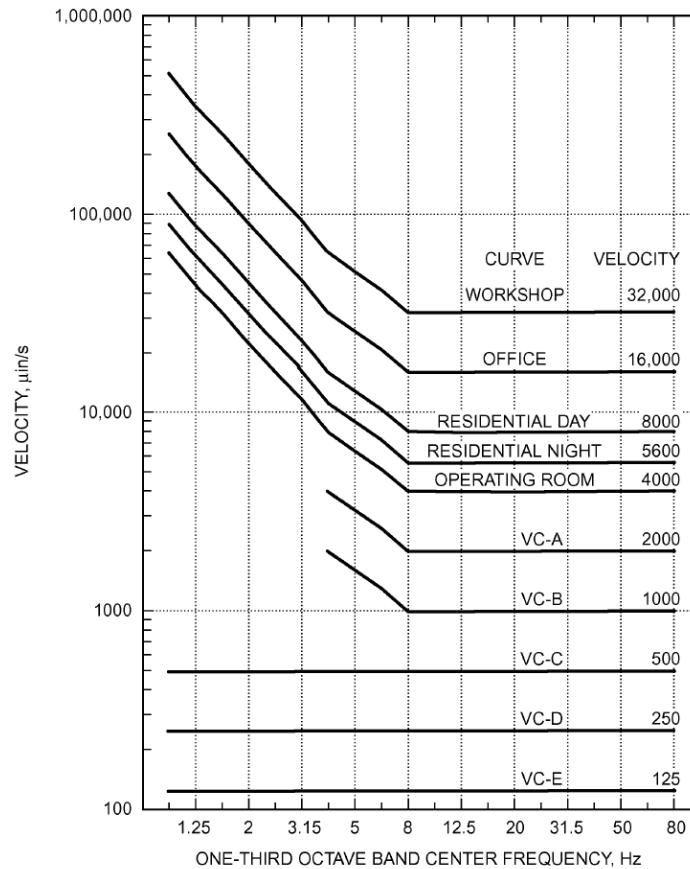
Vibration can be assessed with respect to human response to vibration and for potential damage to sensitive equipment in a building<sup>1</sup>. ASHRAE summarizes acceptable vibration criteria in a building structure. From Figure 1 below, an RMS velocity of 0.032 in/s (32,000  $\mu\text{in/s}$ ) is recommended as a maximum for vibration levels measured in “workshops”.

**Figure 1:** ASHRAE suggested vibration criteria for occupied buildings<sup>2</sup>.

The primary criteria used in this study are the human response to vibration, and the maximum “workshop” criteria suggested by ASHRAE.

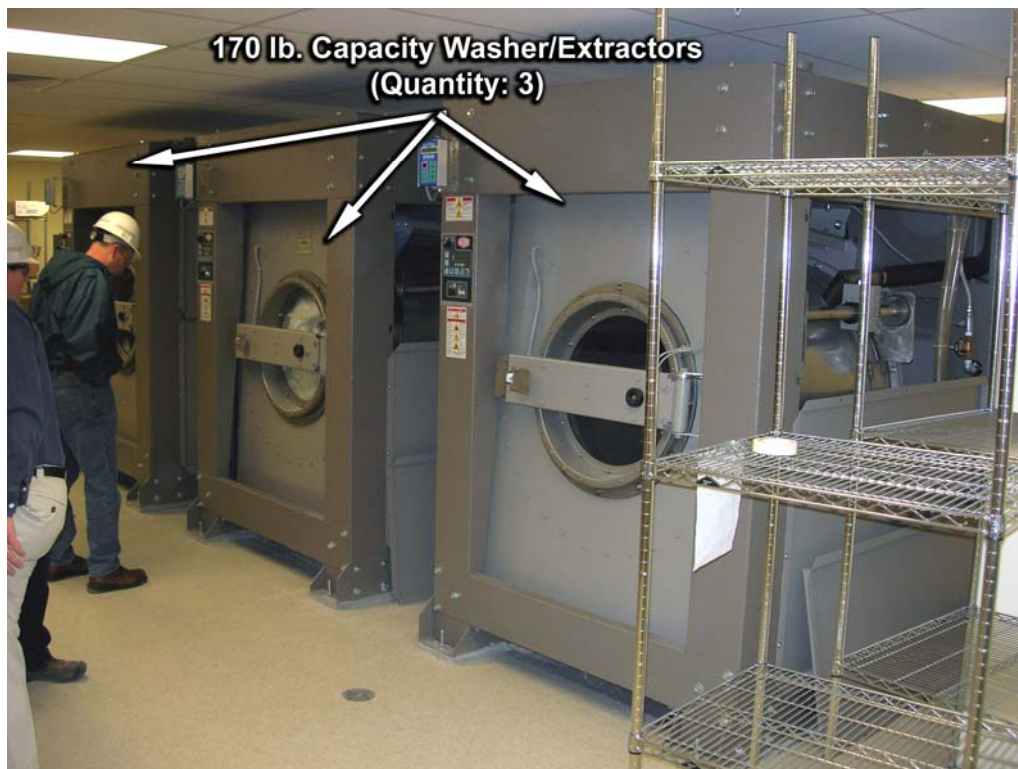
The laundry equipment consisted of a bank of three "soft mount" 170 lb. capacity Pellerin/Milnor #42032X7J washer/extractors, and one "soft mount" 60 lb. capacity Pellerin/Milnor #30022X8J washer/extractor. The washer/extractors were rigidly fastened to the elevated 9" thick post-tensioned flat plate concrete floor slab of the building's 3<sup>rd</sup> sublevel, which spanned 30 ft. between columns. A photo of the installed washer/extractors is shown in Figure 2.

**Figure 2:** 170 lb. capacity washer/extractors as initially installed.

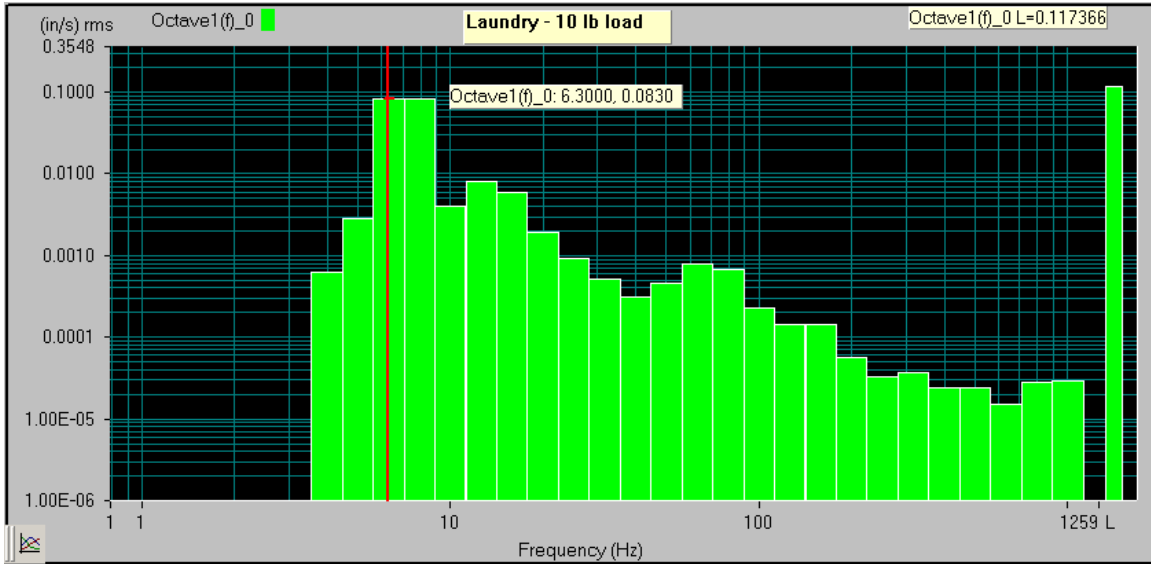
Vertical vibration from these unbalanced loads in a single washer/extractor was measured and found to be far above industry standard criteria for a “workshop” of 0.032 in/s. The data is plotted in one-third octave bands in Figures 4, 5, and 6.

**Figure 4:** Vertical vibration with 10 lb. unbalanced load while accelerating to extraction RPM - 0.083 in/sec at 6.3 Hz and 8Hz, almost 3 times criteria.

In Figure 4, you can see that the vibration velocity levels are almost three times the criteria of 0.032 in/s in the 6.3 Hz and 8 Hz bands, with a 10 pound unbalanced load. Figure 5 shows the data when the machine reached full speed in the extraction cycle. The vibration was much less severe at this speed, and marginally acceptable. Figure 6 shows the vibration levels with an unbalanced load of 20 pounds, which as expected, is approximately twice as severe as with the 10 pound load unbalance. Even though the dynamic force is higher at higher speeds, the vibration levels were highest when the extraction speed passed through the 6.3 Hz one-third octave band, which indicated a resonance condition.

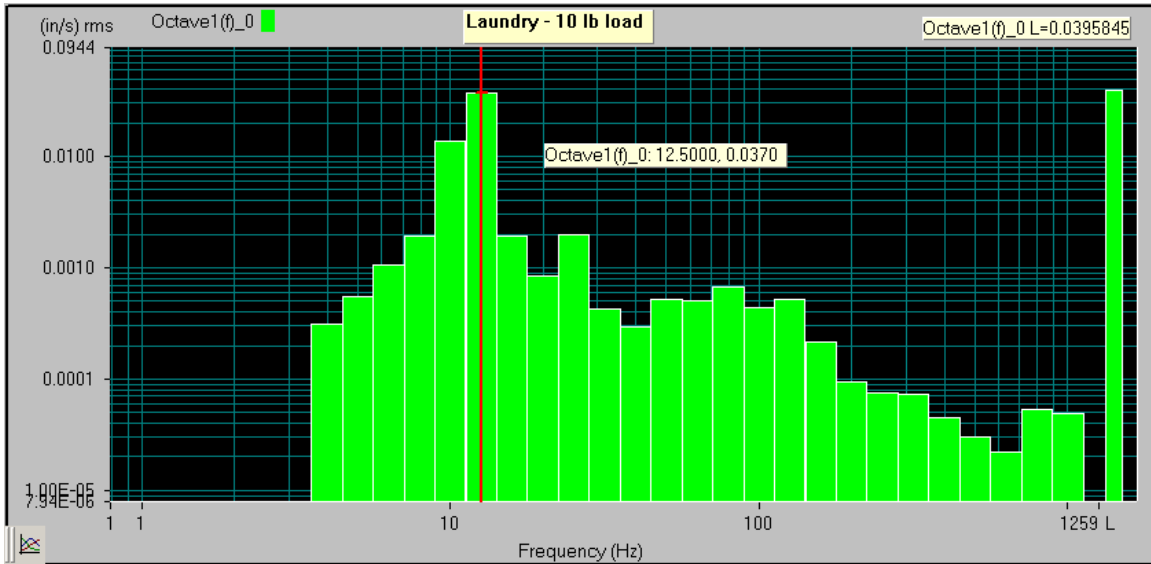
**Figure 5:** Vertical vibration with 10 lb. unbalanced load during steady extraction RPM - 0.037 in/sec at 12.5 Hz, slightly above criteria.

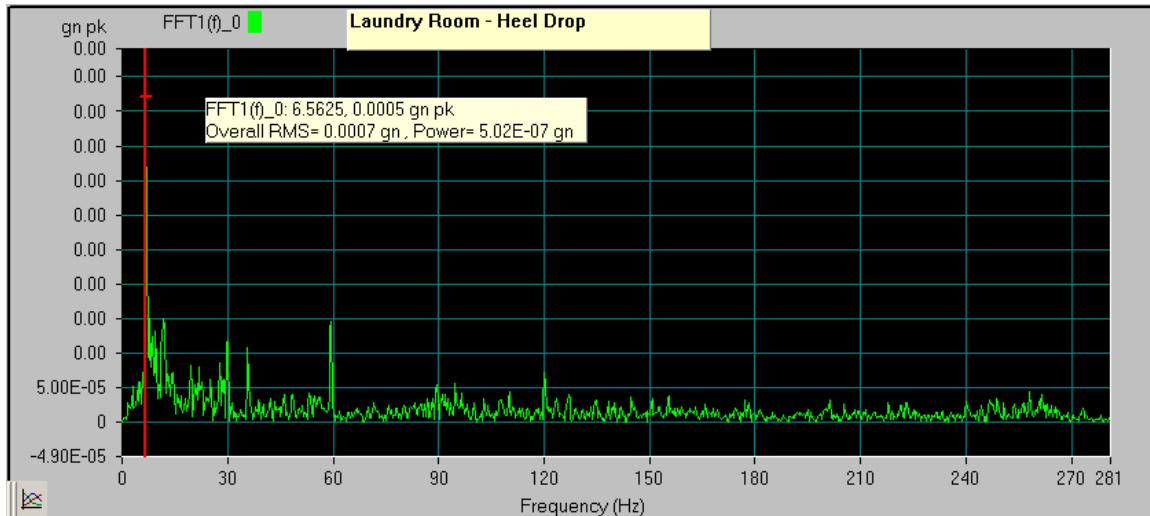
To understand the interaction of the washer/extractors with the supporting structure, it was necessary to determine the natural frequency of the 9" thick post-tensioned concrete floor slab. This was done by exciting the floor slab with a heel drop, and measuring the resulting vibration. Heel drop tests simply involve a person standing with their heels several inches above the floor, and dropping their weight simultaneously onto their two heels. The results of the heel drop test showing a natural frequency of approximately 6.5 Hz are shown in Figure 7.

**Figure 7:** Heel drop test – natural frequency ( $F_n$ ) of laundry floor slab = 6.56 Hz.

Results from the vertical vibration measurements determined that vibration was most severe at 6.3 Hz and 8 Hz with 10 pound and 20 pound loads, respectively, while the washer/extractors were accelerating to their full extraction speed. To achieve a full extraction speed of 12.5 Hz (750 RPM), the machines slowly ramp up over a period of approximately 3 minutes. It is during this ramp up period that the operating frequency (or forcing frequency) of the washer/extractors, matched the natural frequency of the floor, for a period of about 10 to 20 seconds, causing a resonance in the floor slab, and the resulting excessive vibration.

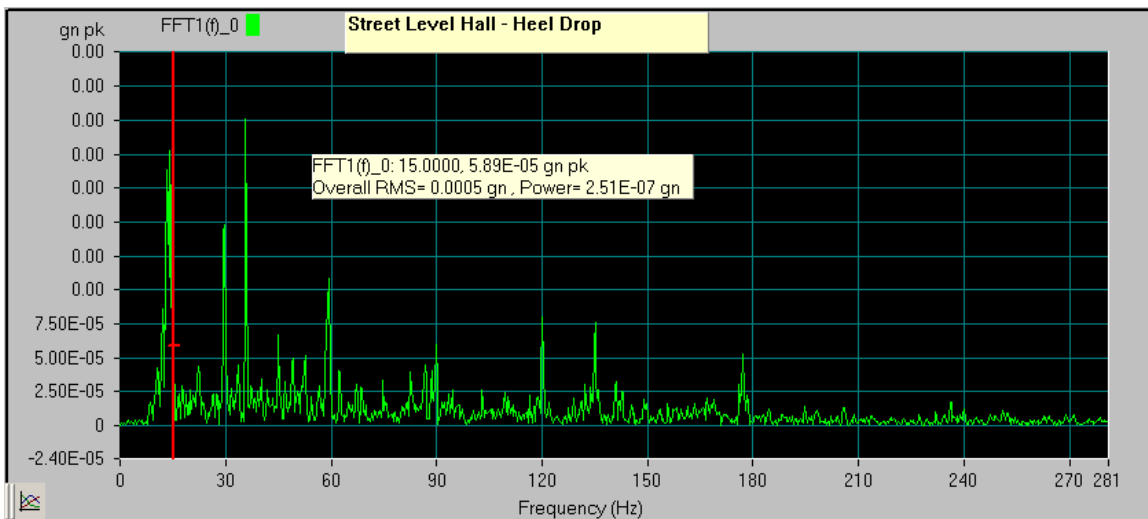
The slab at the First Floor of the hotel was found to be stiffer than that at the laundry, and had higher capacity to carry additional load. However, the occupancies on the floor above were more sensitive to vibration than the laundry area. Heel drop tests were performed on the floor slab at the floor above the laundry, and its natural frequency was found to be approximately 14 Hz, which was close to, but above, the operating range of the washer/extractors. The results of the heel drop test performed at the First Floor are shown in Figure 8. If a resonant condition was experienced, the manufacturer indicated that it was possible to slow the top extraction speed of the machine slightly.

**Figure 8:** Heel drop test – natural frequency (Fn) of First Floor slab = 14 Hz.

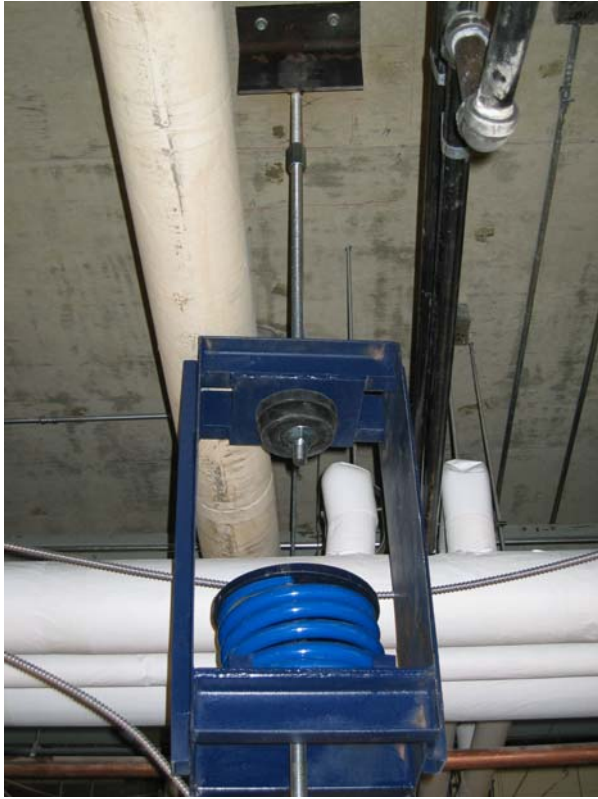
**Figure 9:** Isolation hanger at front of inertia base.

Since the machines must be used in an unmodified condition, isolating the machines on inertia base was the only available option. A common base was selected over individual bases to increase stability. It was determined that an 8” thick inertia base weighing approximately 45,000 pounds would be required to adequately support the machines and isolate vibration from the washer/extractors. However, the load capacity of the laundry floor slab did not allow for a machine/inertia base assembly of that size to be supported mid-span. While it was determined that an inertia base could be adequately supported at the rear of the machines very close to the structural columns, it was impossible to support the front of the inertia base from the floor. The idea of suspending the inertia base from the floor-slab above was proposed.

It was decided to mount the rear of the inertia base on the floor of the laundry room near the structural columns, and the front of the inertia base would be suspended from the First Floor slab above. While this required removal of the existing lay-in ceiling system to install spring hangers, most of the electrical and supply/waste piping for the washer/extractors could remain in place. Figures 9, 10, and 11, depict progress of the inertia base installation.

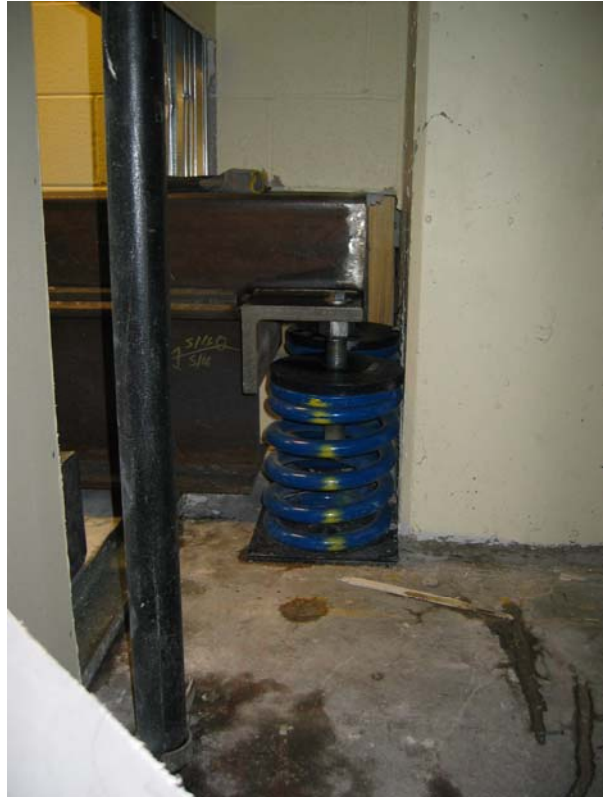
**Figure 10:** Spring isolator at rear of base at column.

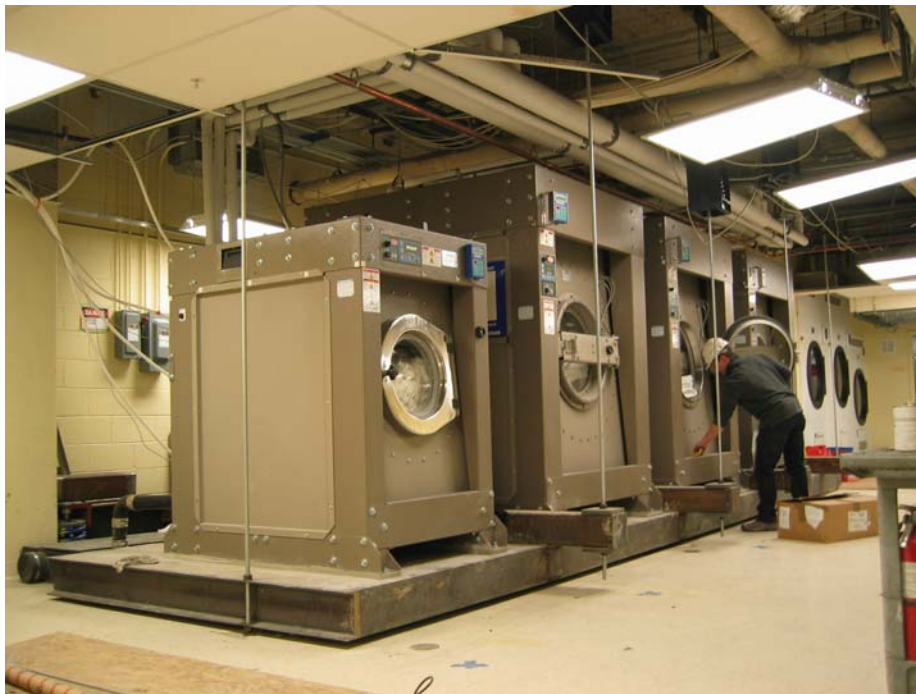
**Figure 11:** Inertia base during installation.

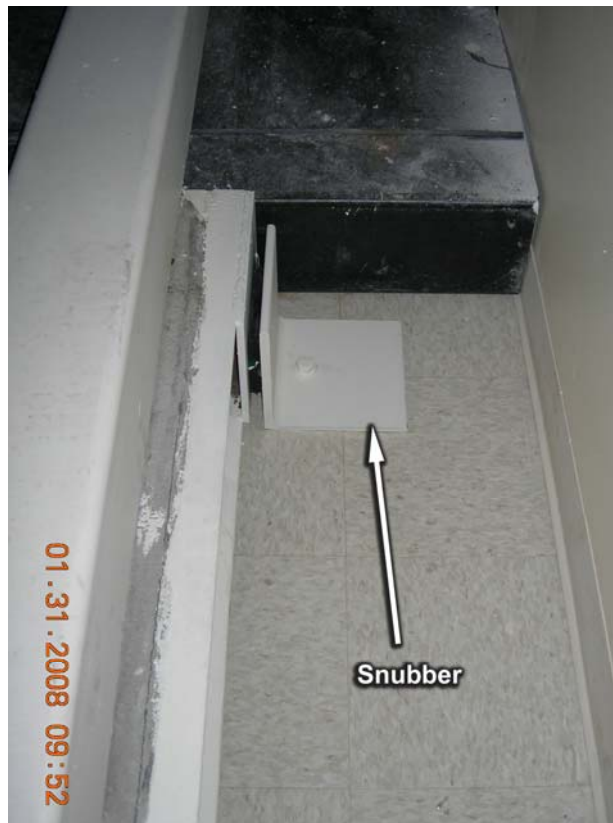
Some minor modifications were required after the initial installation. The required clearance around the inertia base was not provided and there was contact between parts of the inertia base and the floor. This was remedied by chiseling the floor in small areas. Approximately ½” of movement (peak-to-peak) was expected at the natural frequency of the spring isolators, and this was very close to the movement experienced as the extractor began to ramp up its speed. Another issue was the lateral movement of the inertia base. The machines transmit horizontal forces as well as vertical forces. This was anticipated, but a decision was made to take a “wait and see” approach to determine how significant the movement due to these loads was. The floor mounted springs were able to resist the horizontal loads with minimum lateral movement, but the front of the inertia base that was suspended tended to sway. The movement in itself, up to ½”, was not a problem. However, the lateral movement caused an internal limit switch on the washer/extractors to trip occasionally. To limit this movement, snubbers were installed on the floor, at the two ends of the base, to restrict the lateral movement of the base. Installed snubber, which consisted of neoprene waffle pads and steel angle, is shown in Figure 12.

**Figure 12:** Snubber installed at end of inertia base to restrict lateral movement.

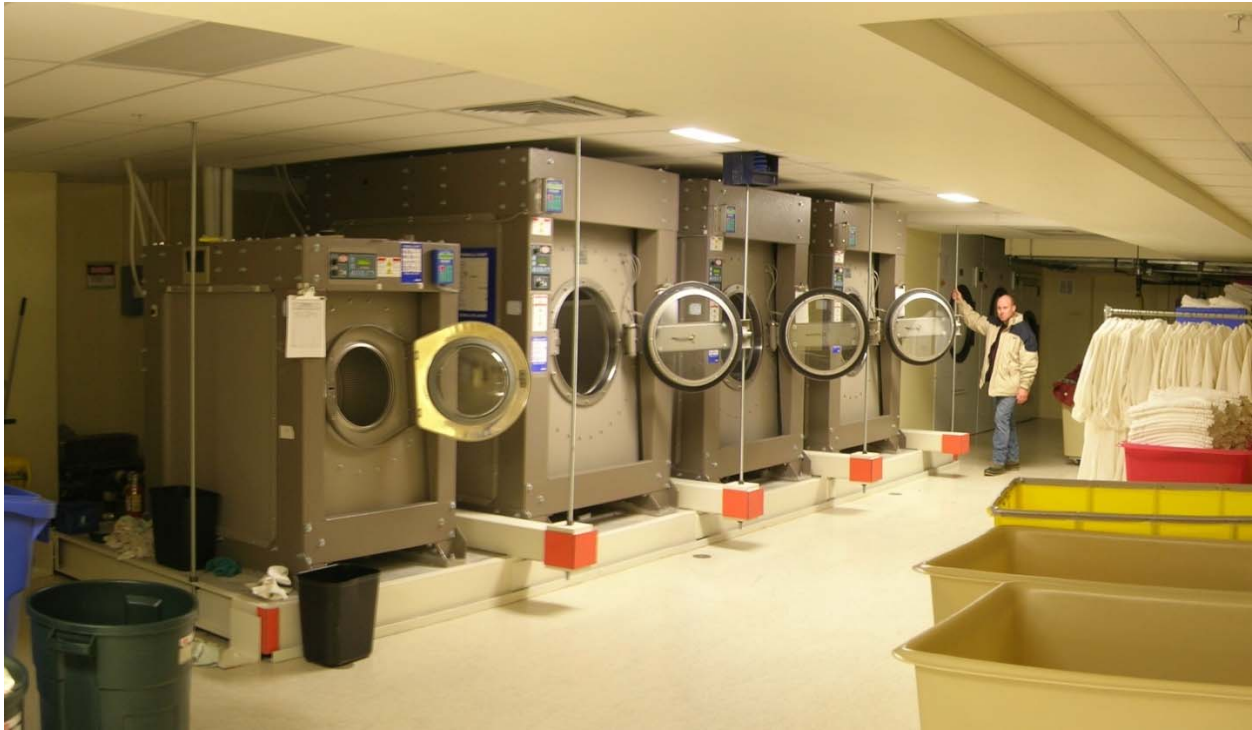
The final installation of the washer/extractors on the inertia base is shown in Figure 13.

**Figure 13:** Washer/extractors on retrofitted inertia base.

While vibration could not be measured after installation of the inertia base was complete, vibration was subjectively difficult to detect. Moreover, the owner was satisfied with the results, as the hotel was able to commence with onsite laundry operation, and meet their grand opening date.
