Flanking paths associated with exposed roof decks in condominiums

Jeffrey P. Kwoikoski^{a)}
D. L. Adams Associates, Inc.
1701 Boulder Street
Denver, CO 80211

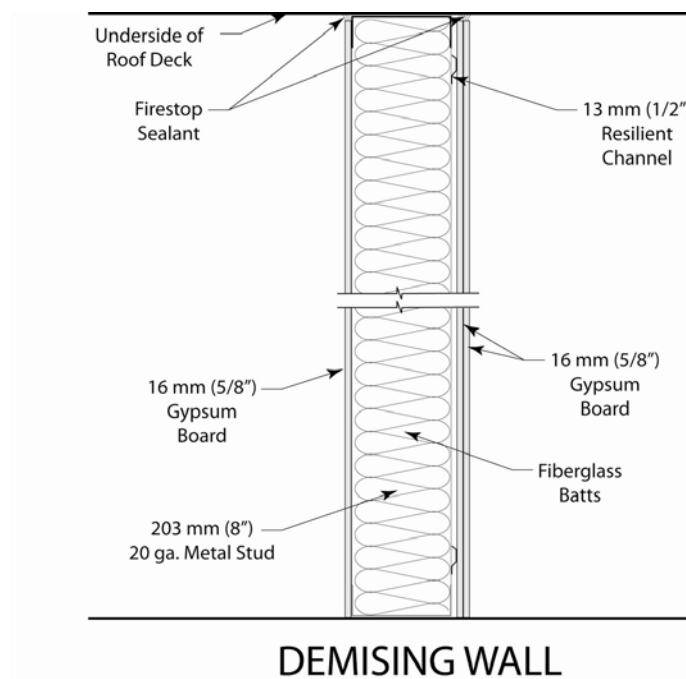
Before visiting the site, we evaluated the demising wall construction. According to the drawings and statements from the general contractor, the demising wall consisted of one layer of 16 mm (5/8") gypsum board on one side, and two layers of 16mm (5/8") gypsum board on the other side of 203 mm (8") deep 20 gauge metal studs, placed 406 mm (16") on center. The stud cavity was filled with fiberglass batt insulation. The gypsum board on one side of the wall was mounted on 12 mm (1/2") resilient channels. The total wall thickness was 251 mm (9-7/8"). Please refer to **Figure 1** for the wall construction. We estimated the wall's Sound Transmission Class (STC) to be approximately 58. We would not expect the complaints that the owner was receiving if the wall was built properly and there were minimal sound flanking paths.

Fig. 1 - Demising wall construction.

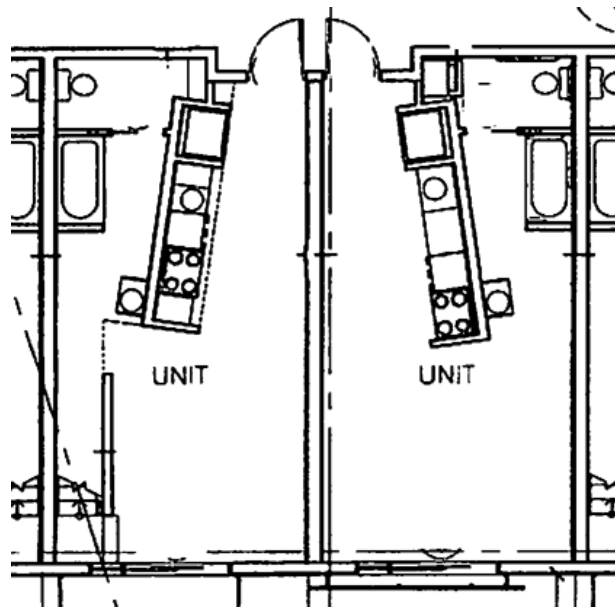
deck. The ASTC was 41. Refer to the “ASTC 41” curve in **Figure 5** for the test results, and refer to **Figure 6** for the floor plan of the two units. The ASTC rating was limited by the large dip in sound Transmission Loss at 630 Hz and 800 Hz.

Fig. 6 - Floor plan of test units.
